Degree of Damage Guideline

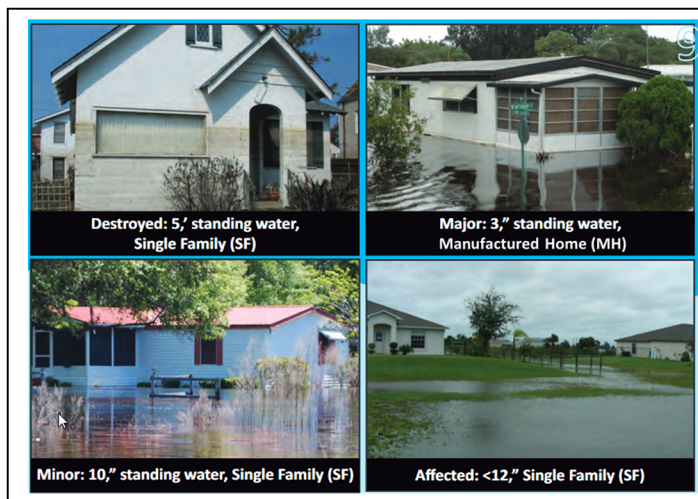
Flood Water Depth Chart

Damage Level	Conventionally Built Structure	Manufactured Home
Affected	Waterline in the crawl space or an unfinished basement when essential living spaces or mechanical components are not damaged or submerged.	No damage affecting habitability, cosmetic damages only.
Minor	Waterline at 1" to 3" in an essential living space. <i>When waterline exceeds 3" but is below 18", damage may be major or minor, depending on the following factors: duration of the flood, contaminants in the water, if waterline reached electrical outlets, and number of essential living spaces flooded.</i>	When the waterline has reached the floor system but has not entered the living space of the unit.
Major	Waterline above 18" or the electrical outlets in an essential living space.	Water has covered the floor system and entered the living space of the unit but is still below the roofline.
Destroyed	Waterline at the roofline or higher, or complete failure of two or more major structural components.	The residence is a total loss, for example: Waterline is at the roofline or higher; Residence's frame is bent, twisted, or otherwise compromised.

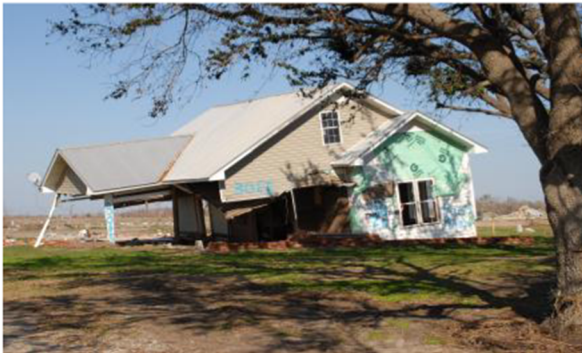
The foundation and two or more walls of this residence have failed.

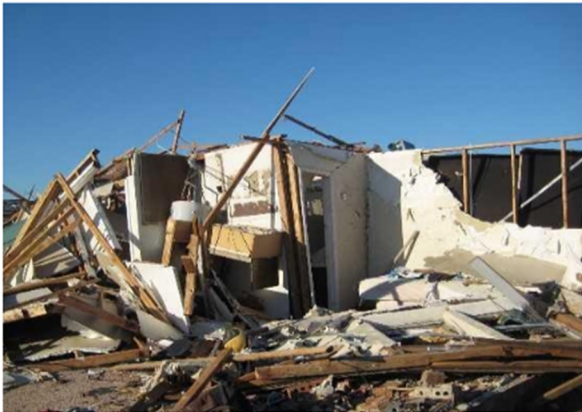
This residence has collapsed.

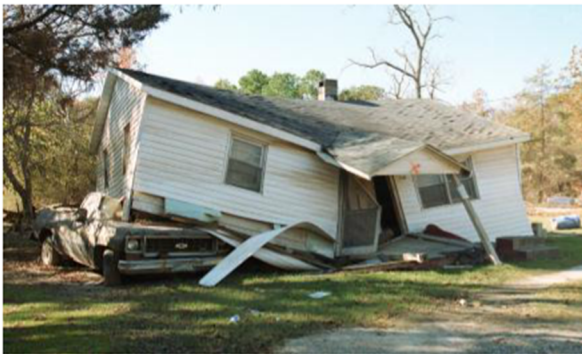
The roof and walls of this home have been compromised and it is off its foundation.

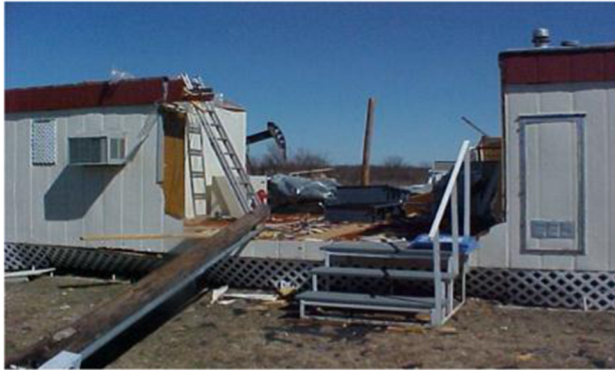
The manufactured home is missing the roof and at least two walls.

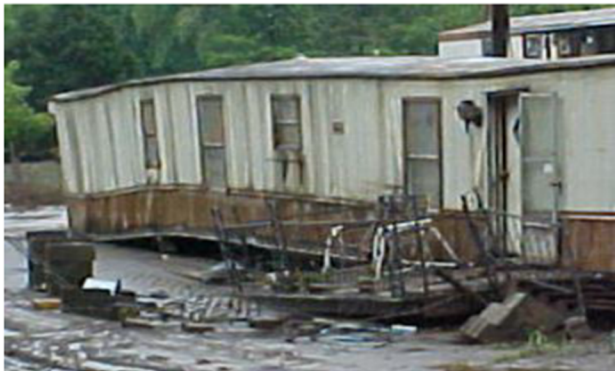
The frame of the manufactured home has been bent.

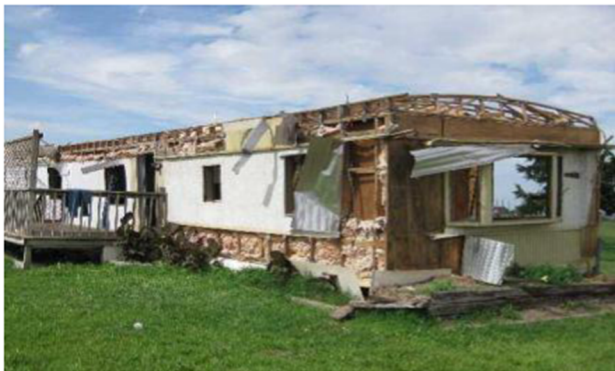
This manufactured home is missing the roof covering, and at least one wall has been compromised.

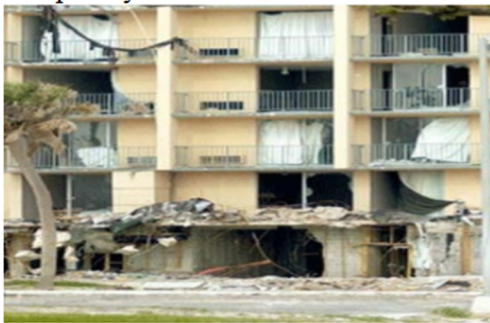
Based on this view, at least 12 units should be classified as having major damage. All units in an apartment building will not necessarily have the same damage level.

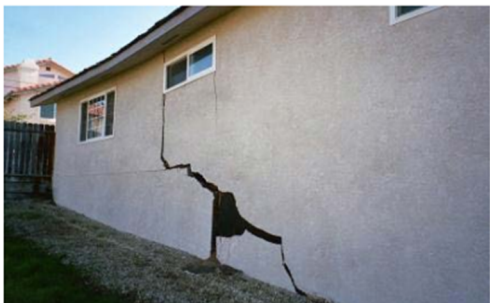
The structural elements of this wall have failed.

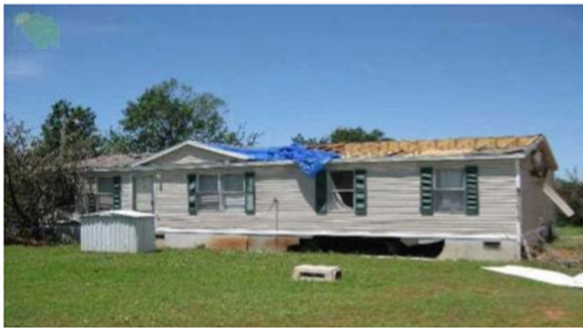
Although much of the roof is missing, the structural ribbing of the roof system is still intact.

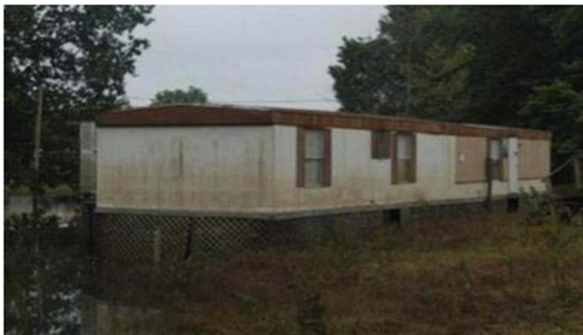
Visible water line above the floor system.

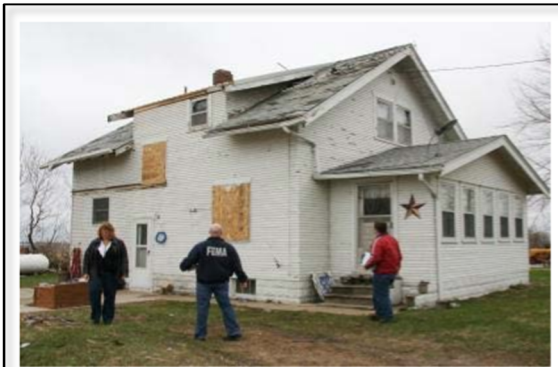
This residence has nonstructural damage to the roof and broken windows.

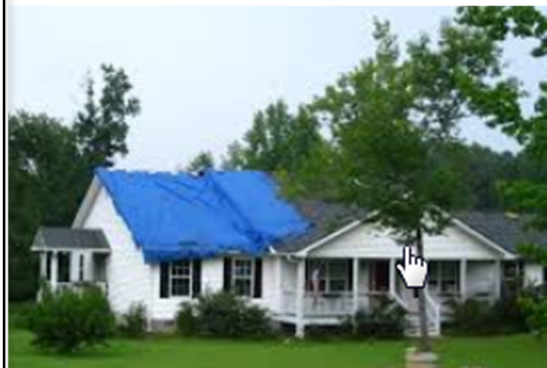
The roof on this residence has been tarp covered after it lost some shingles.

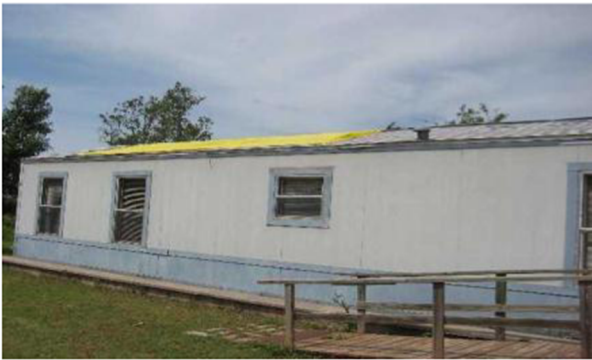
A portion of the roof has been damaged.

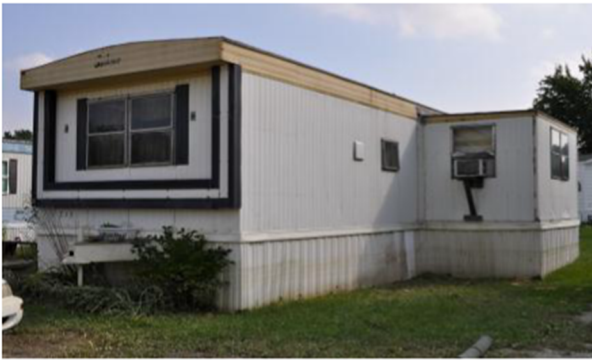
The visible water line is below the floor system.

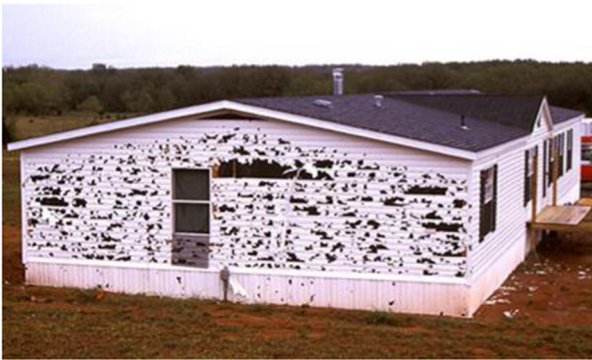
Nonstructural components of one wall have sustained damage.

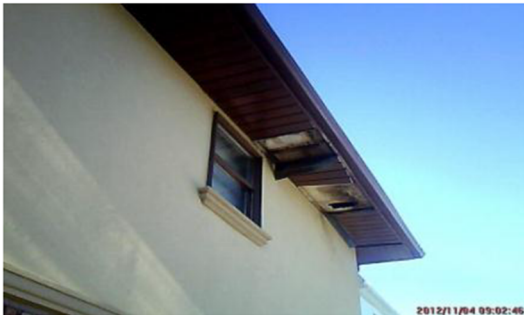
Damage to this soffit represents nonstructural damage to the roof.

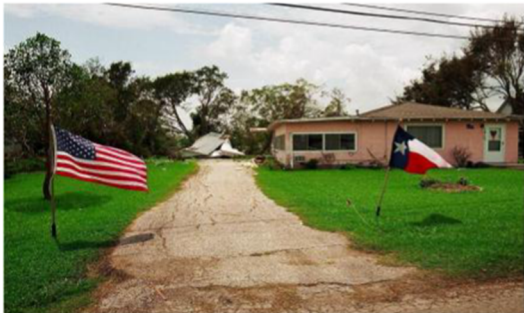
Only an outbuilding has sustained damage.

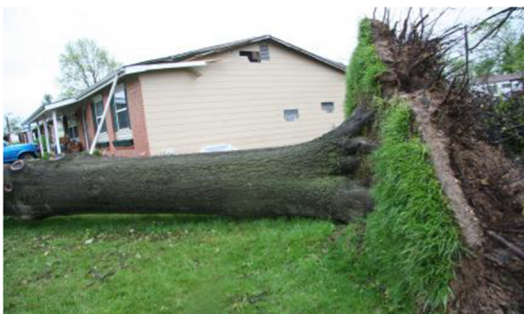
The residence has gutter and roof damage. The tree does not impact the damage level of the home.

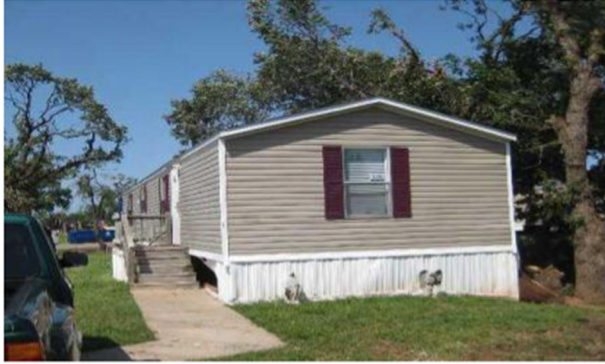
The only damage to this manufactured home is the missing skirting.

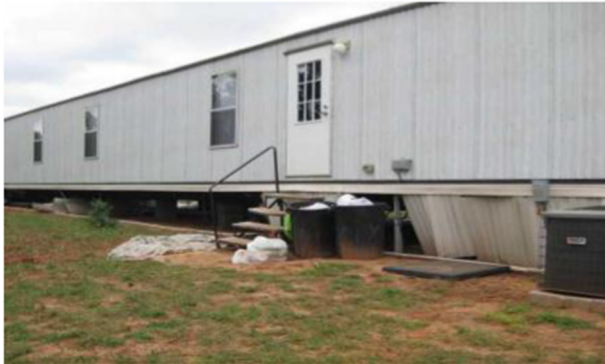
There is no visible water line and only skirting is missing or bent.
